D.L. Ricci Corp. Case Study #314

"Big BU to the Rescue"

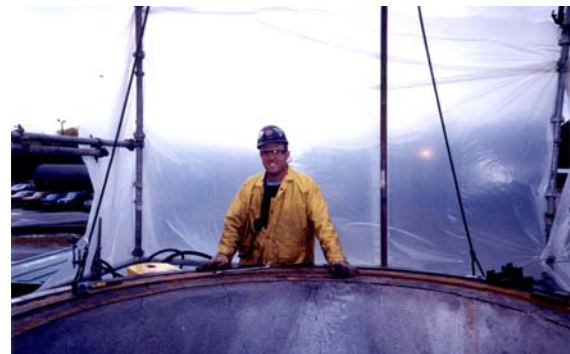
Before

- We prepared by having our product and people ready at a moments notice
- An upper Midwest refinery was undergoing some outage maintenance work disassembling a flange when their contactor went into the gasket surface
- They needed the surface refinished and they needed it done now

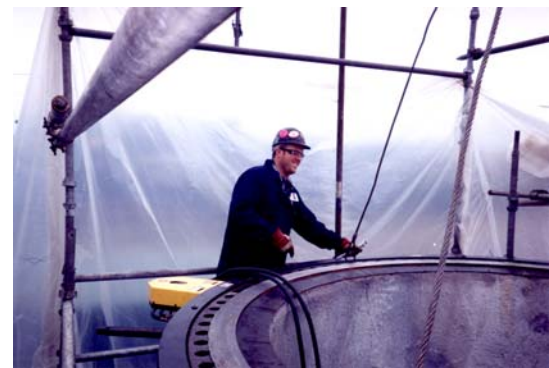
After

- The flange was resurfaced and the refinery was back on schedule
- The BU110 proved its durability & portability in these harsh conditions
- The client was ecstatic, "D.L. Ricci Corp. came through"

- Within an hour of receiving the call we had our BU110 onsite and 4 men for 5 shifts of flanging
- With an outdoor site, the crew had to put up with plenty of rain and cold
- The BU110 performed as promised and flanging was done efficiently
