D.L. Ricci Corp. Case Study #314

"Big BU to the Rescue"

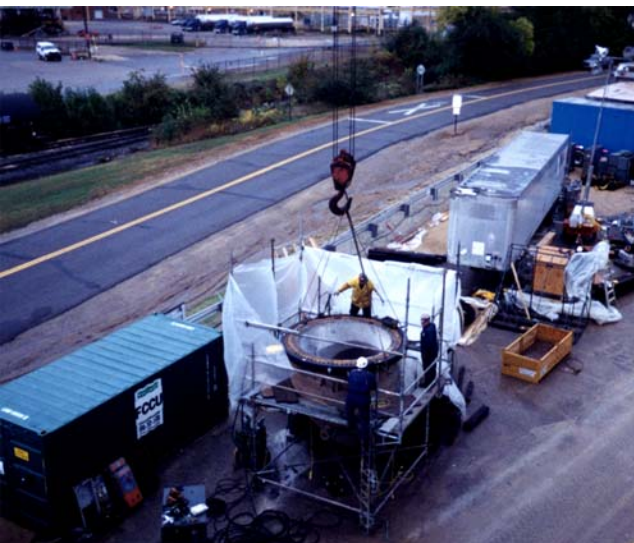
Before

- We prepared by having our product and people ready at a moments notice
- An upper Midwest refinery was undergoing some outage maintenance work disassembling a flange when their contactor went into the gasket surface
- They needed the surface refinished and they needed it done now

- Within an hour of receiving the call we had our BU110 onsite and 4 men for 5 shifts of flanging
- With an outdoor site, the crew had to put up with plenty of rain and cold
- The BU110 performed as promised and flanging was done efficiently

- The flange was resurfaced and the refinery was back on schedule
- The BU110 proved its durability & portability in these harsh conditions
- The client was ecstatic, "D.L. Ricci Corp. came through"
